Removal of natural obstructions to improve Atlantic Salmon and Brook Trout habitat in western NL

26/02/2015
Version 2.0

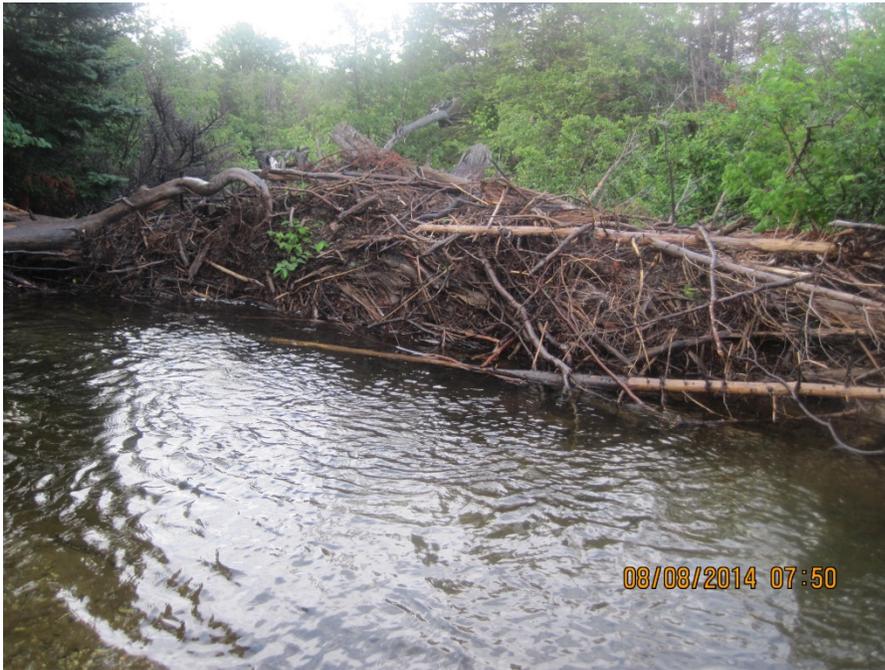
Figure 1: First obstruction (downstream) on Sheep Brook, Flat Bay Brook, during low water in August. This section blocks the main fork of Sheep Brook.

The downstream obstruction on Sheep Brook consisted of two large log jams that spanned two separate forks. These log jams were extensive and resulted in a considerable reservoir of water developing upstream of the obstruction. The log jam obstructing the main fork of Sheep Brook measured 1.7 m in height and was 14.9 m in length (Table 1). Due to the extensive snow cover, accurate measurements for obstruction 2 on Sheep Brook and Obstructions 1 and 2 on Cold Brook were not carried out.

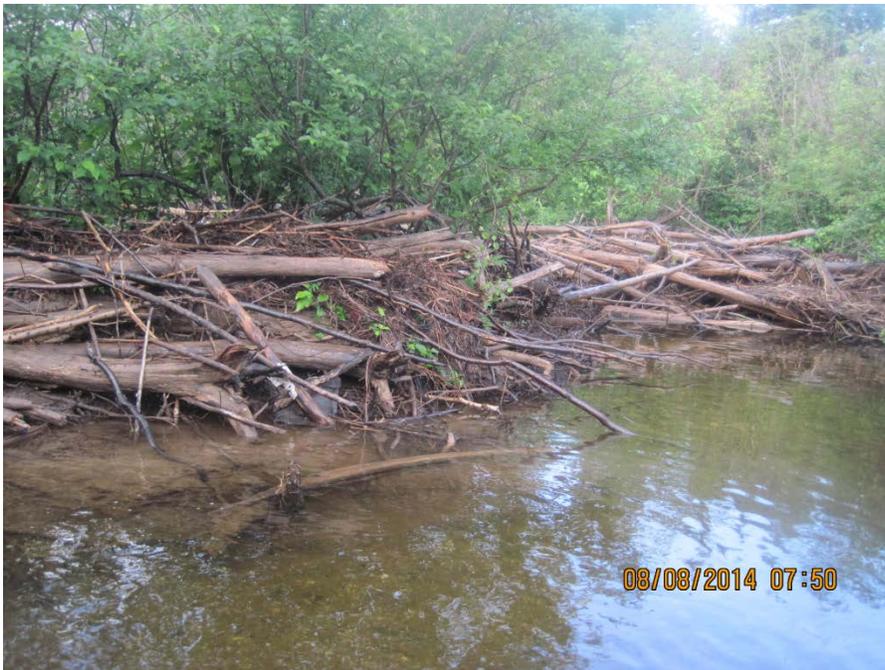
Figure 2: First obstruction (downstream) on Sheep Brook, Flat Bay Brook, during low water in August. This section blocks a secondary fork of Sheep Brook.

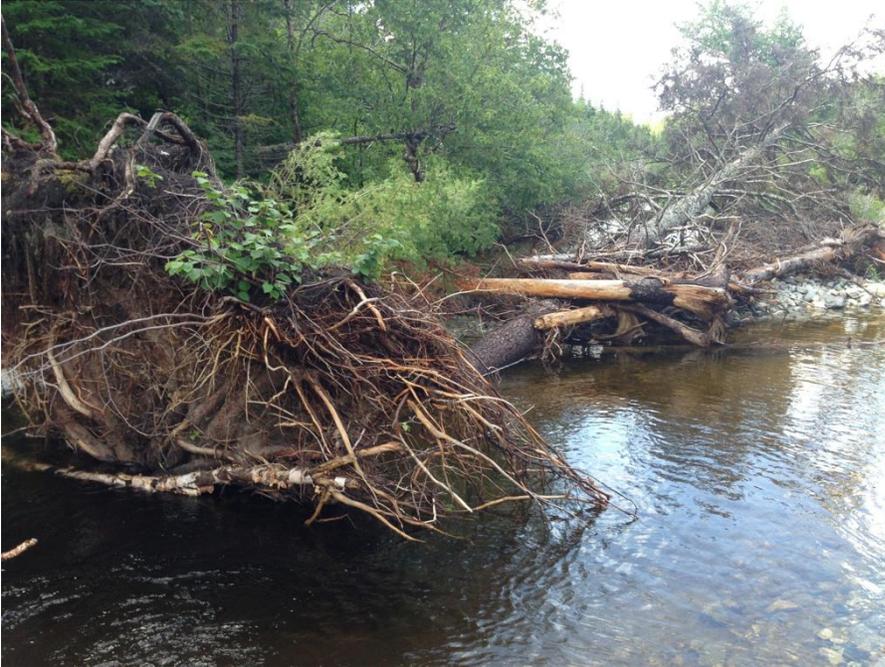
Figure 3: Second obstruction (Upstream) on Sheep Brook, Flat Bay Brook, during low water in August.

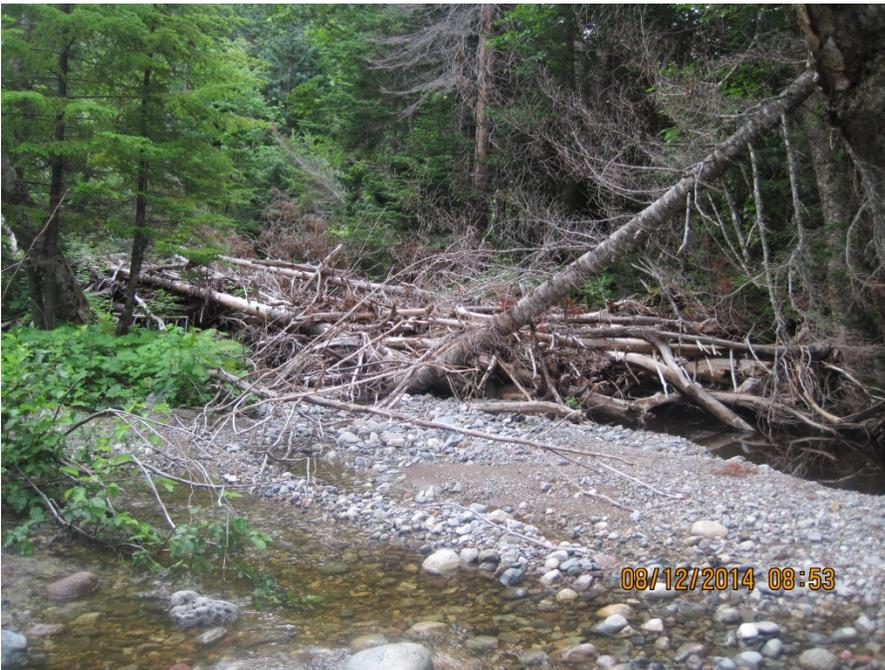
Figure 4: First obstruction (downstream) on Cold Brook, Flat Bay Brook, during low water in August.

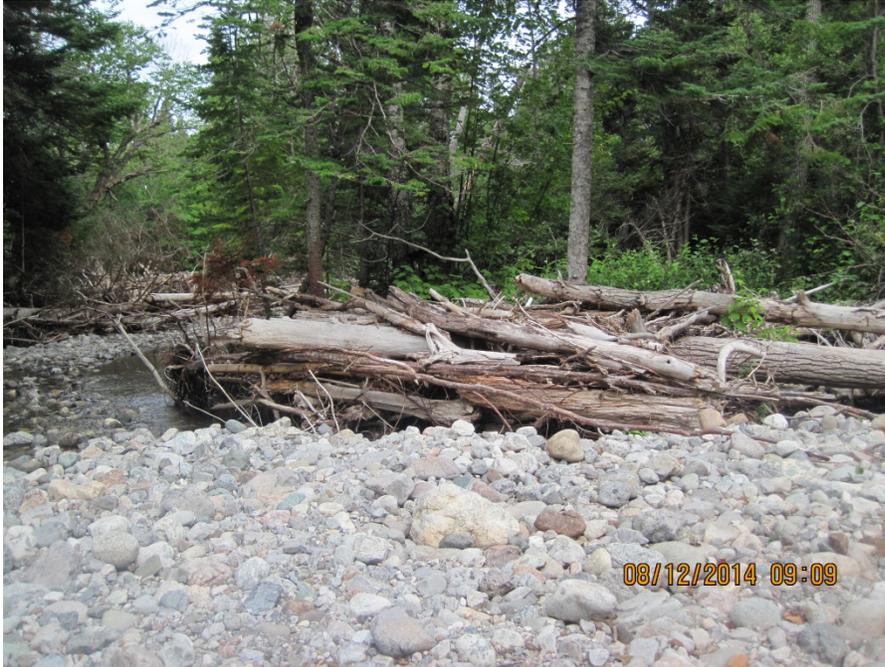
Figure 5: Second obstruction (downstream) on Cold Brook, Flat Bay Brook, during low water in August.

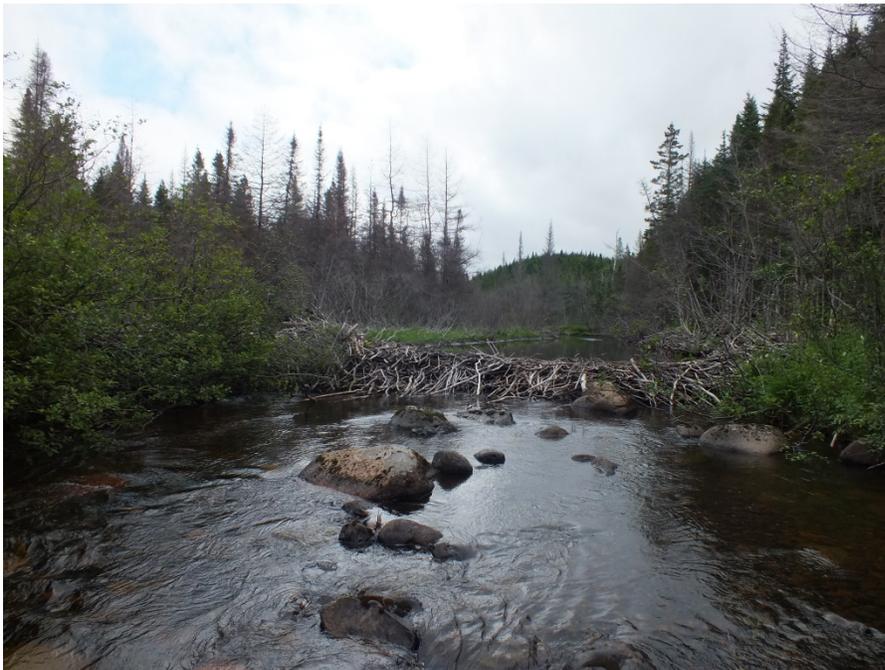
Figure 6: First obstruction on Ahwachenjeech, Harry's River, during low water in August.

During low water in August, the first obstruction on Ahwachenjeech hindered the downstream movement of water, resulting in the pooling and damming of water upstream (Appendix A). Although water flowed freely over the first obstruction on Ahwachenjeech during high water in December, a considerable reservoir had formed (Appendix B). Obstruction 1 on Ahwachenjeech was 1.0 m in height, with a downstream plunge depth of 0.4 m during high water in December. The height of the obstruction during high water was 2.5 times greater than the plunge depth, which is sufficient to block the upstream migration of Atlantic Salmon (Bjornn and Reiser 1991). Low water during the summer and fall would increase the height differential between plunge depth and obstruction height, preventing the upstream migration of Atlantic Salmon. The second obstruction on Ahwachenjeech was smaller in size, but was extensive enough to impede the movement of water downstream (Appendix B). This obstruction measured 8.9 m across the stream and was 0.9 m in height. The plunge depth was 0.6 m during high water in December, which may not prevent the movement of Atlantic Salmon, but will seriously impede migration of Brook Trout during lower water in the summer and fall. Low water during the summer and fall may increase the height differential at the second obstruction, fully impeding upstream migration of Atlantic Salmon.

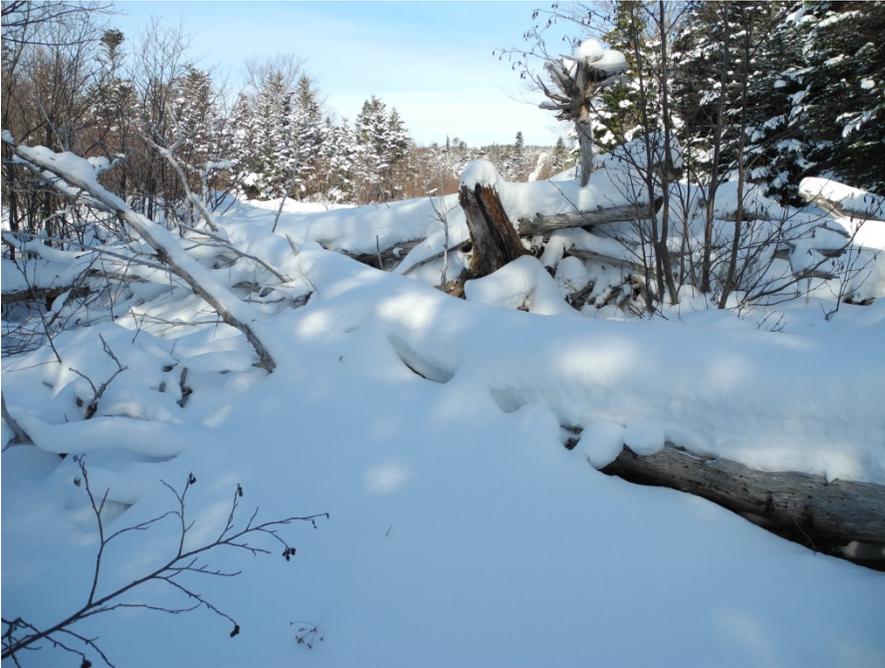
Figure 7: First obstruction (downstream) on Sheep Brook, Flat Bay Brook, in January. This section blocks the main fork of Sheep Brook. Coordinates: 48.38358, -58.42901

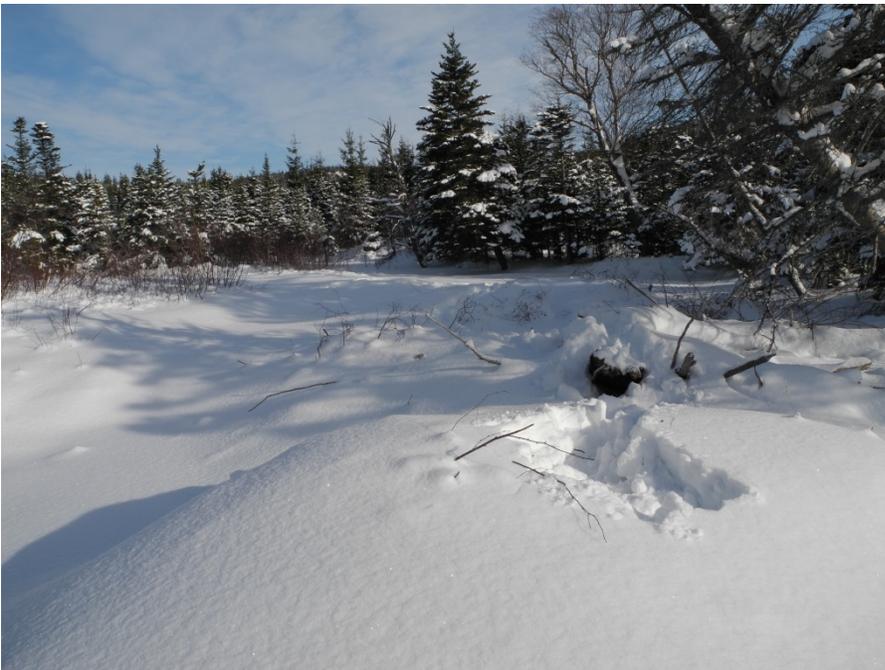
Figure 8: Second obstruction (upstream) on Sheep Brook, Flat Bay Brook, in January. Coordinates: 48.38456, -58.42939

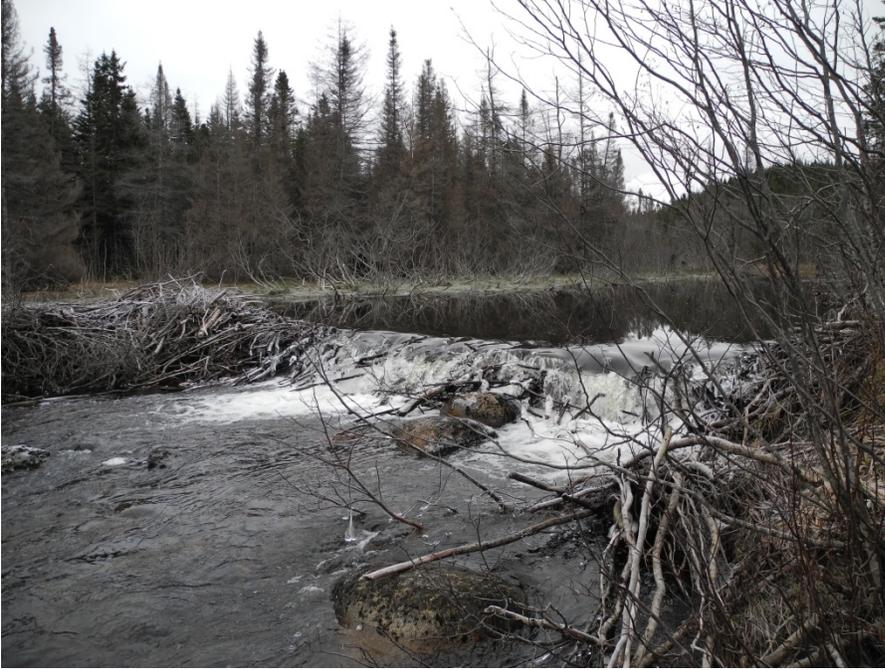
Figure 9: First obstruction (downstream) on Ahwachenjeech, Harry's River, during high water in December. Coordinates: 48.65230, -58.26805

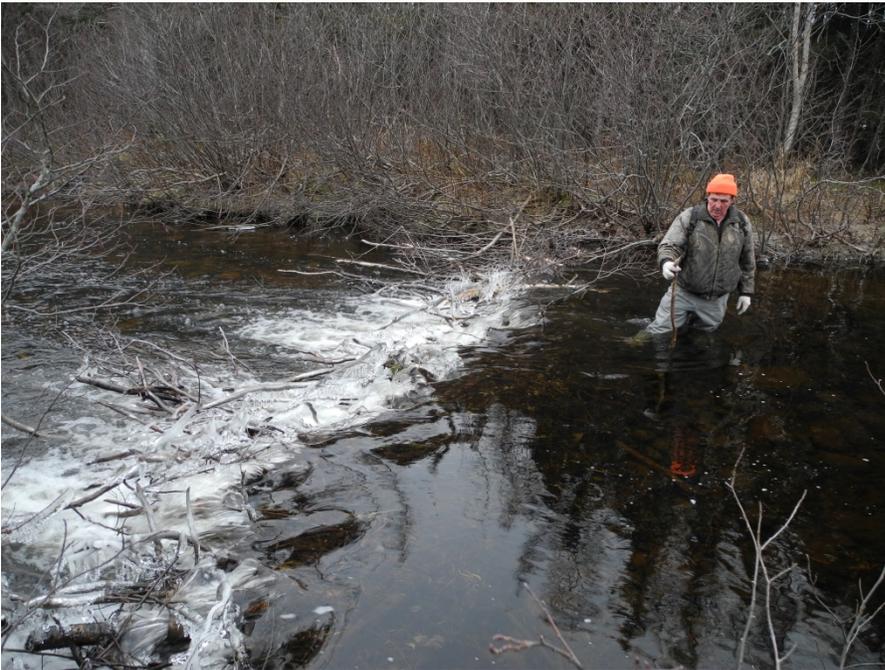
Figure 10: Second obstruction (upstream) on Ahwachenjeech, Harry's River, during high water in December. Coordinates: 48.65308, -58.26483
